CASE HISTORY

PARKING DECK WATERPROOFING SYSTEM RESTORATION

COST-EFFECTIVE TRAFFIC COATING OVERCOAT FOR ACTIVE COMMERCIAL FACILITY – HAWTHORNE, CALIFORNIA

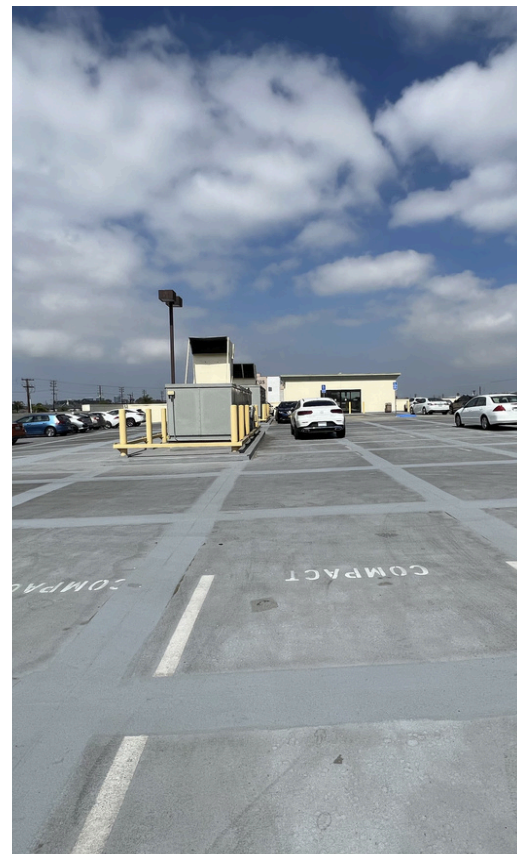
- Water intrusion into the facility caused by deterioration of the existing waterproofing membrane and failing joint sealant throughout the parking deck.
- Loss of surface texture over time, resulting in a smoother floor profile and reduced traction for vehicle and pedestrian traffic.
- Declining topcoat performance, including reduced chemical resistance and visible staining from vehicle fluids, tire plasticizers, and operational wear.

Working closely with the product manufacturer's technical representative, our team developed a multi-layer traffic coating overcoat system designed to properly bond to the existing surface. The scope included detailed cleaning, mechanical surface preparation, and resealing of all expansion and control joints using flexible sealant and reinforcing polyester fiber to help bridge future movement and reduce the risk of delamination.
